PROGRESS REPORT

LOWER YELLOWSTONE RIVER EROSION CONTROL

SOIL AND MOISTURE CONSERVATION PROGRAM

July 1972

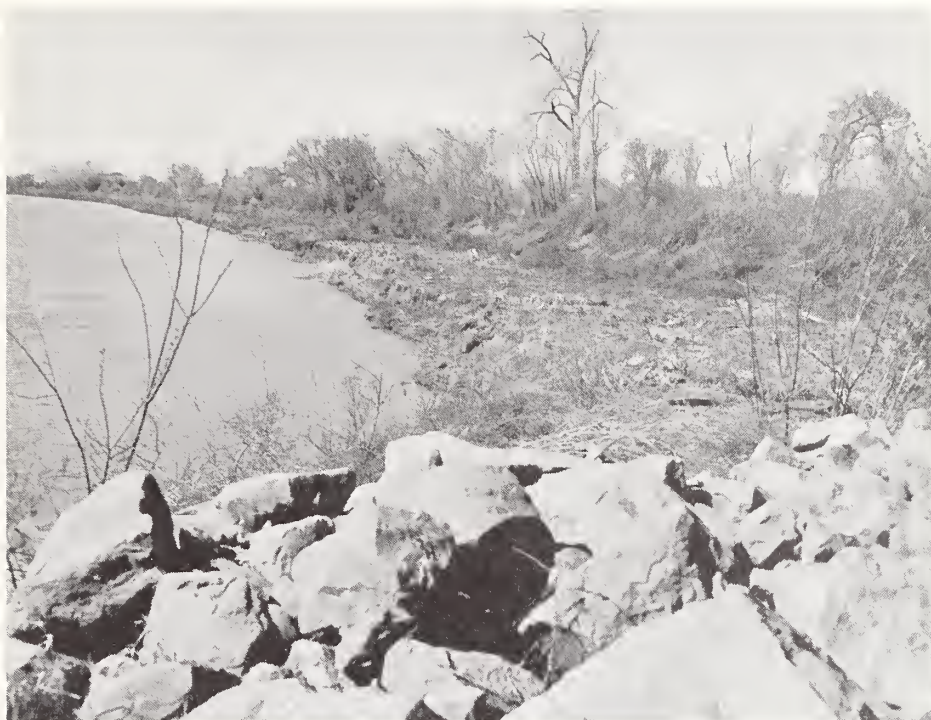
The river has deposited a berm along the bank above the jetty which is very desirable.

P14-600-368NA--Lower Yellowstone S&MC--May 7, 1970. Richland Park jetty. Berm formed above jetty which was constructed in 1965.

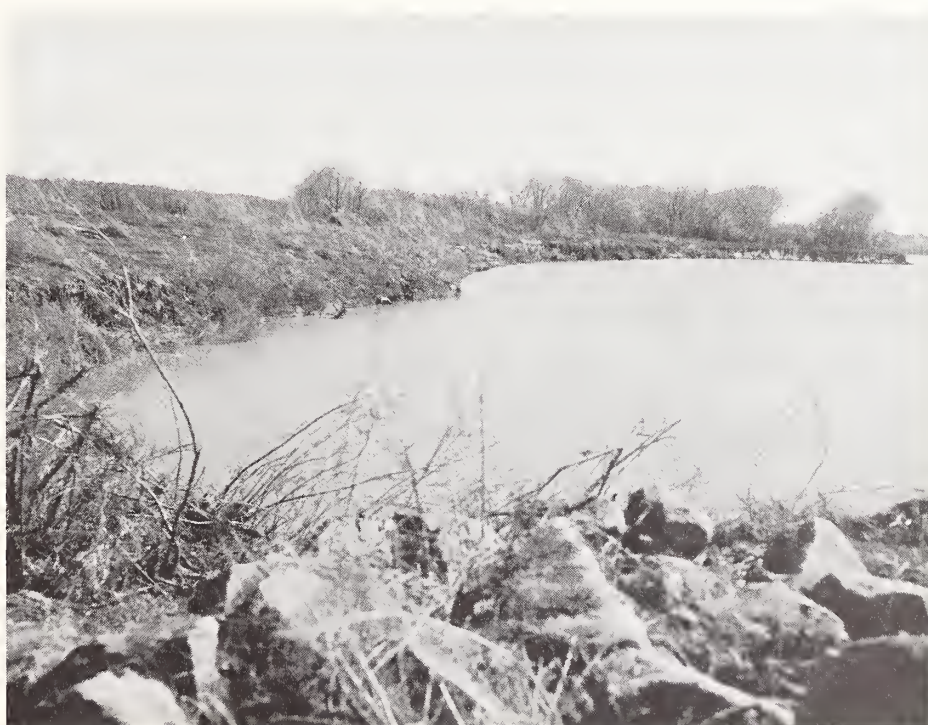
Immediately below the jetty the banks are still vertical and raw but do not appear to be eroding seriously. Two or possibly three additional jetties or jacks below Richland Park and above Lateral G jetties may be required before this area of river bank becomes stabilized.

P14-600-369NA--Lower Yellowstone S&MC--May 7, 1970. Below Richland Park jetty. Shows effects of ice flows on large willows.

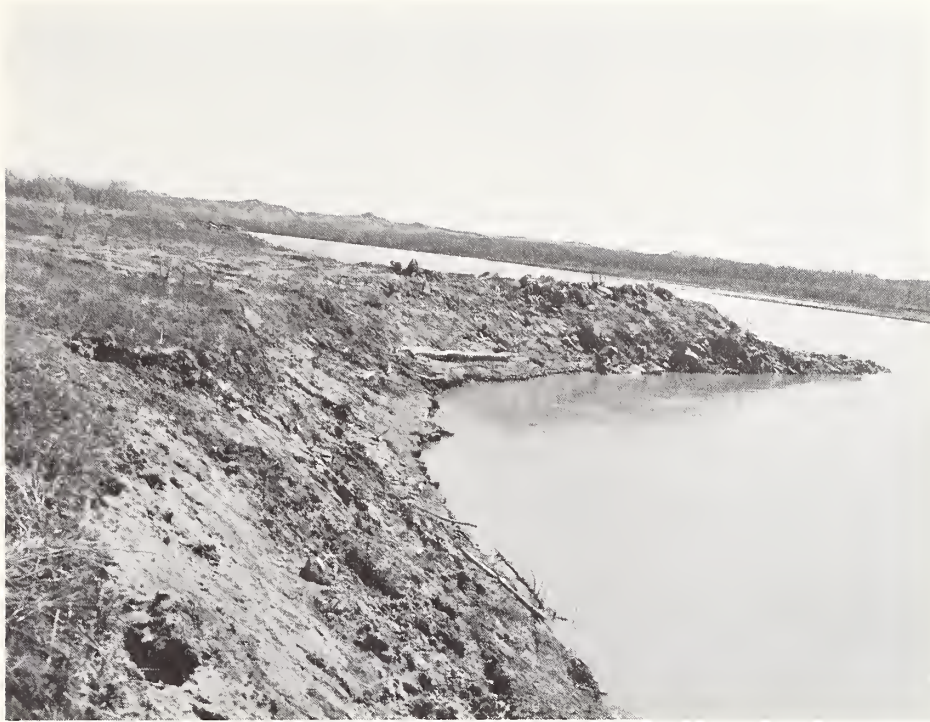
There was considerable turbulence around these jetties. In order to minimize the effects of the turbulence, some gravel blanketing has been placed on sloped banks, and car bodies and junk was hauled in (a now illegal practice in Montana) by the Irrigation Districts or the landowner to stabilize the banks. A total of 300 steel jacks were placed to support the jetties in stabilizing the banks.

P14-600-365NA--Lower Yellowstone S&MC--May 7, 1971. Lateral G - Hanson area. Rock jetty with point eroded by ice flows.

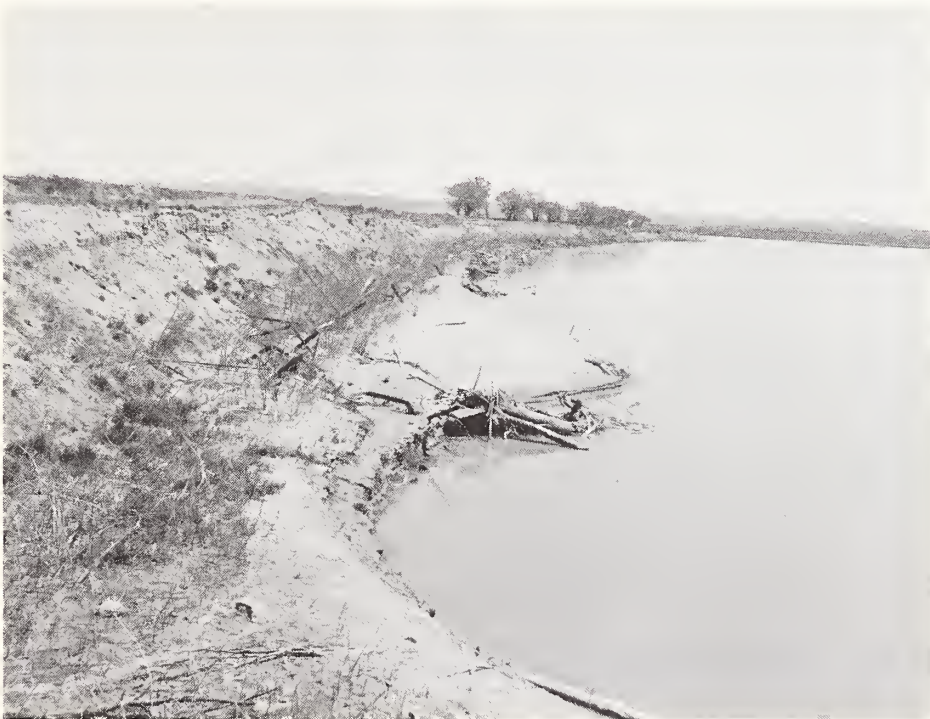
P14-600-344NA--Lower Yellowstone S&MC--May 7, 1971. State line-Lateral H area, bank below second jetty stabilized by steel jacks. Note vegetation.

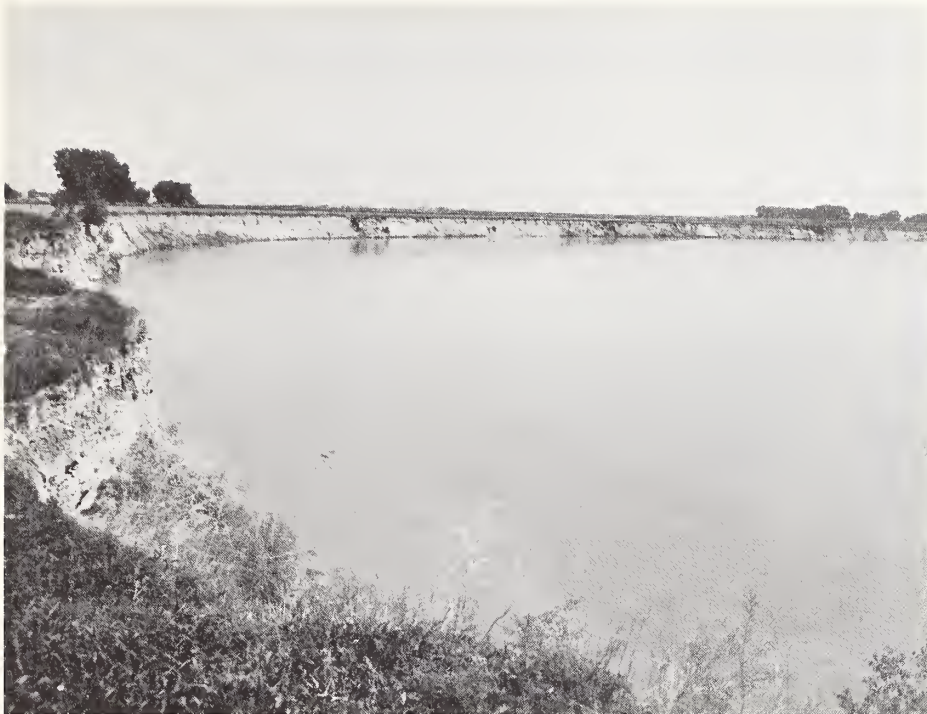
The Charal farms area, which is in Sec. 1, T. 21 N., R. 58 E., is part of the Lateral PP-3 system and it is immediately above the original jetties. This area has been eroding severely. During FY 1971 and 1972, the bank was graded to a 3:1 or 4:1 slope for nearly 3,000 feet. It was covered with a gravel blanket.

P14-600-371NA--Lower Yellowstone S&MC--June 9, 1970. River bank in Lateral PP-3, Charal Farms area.

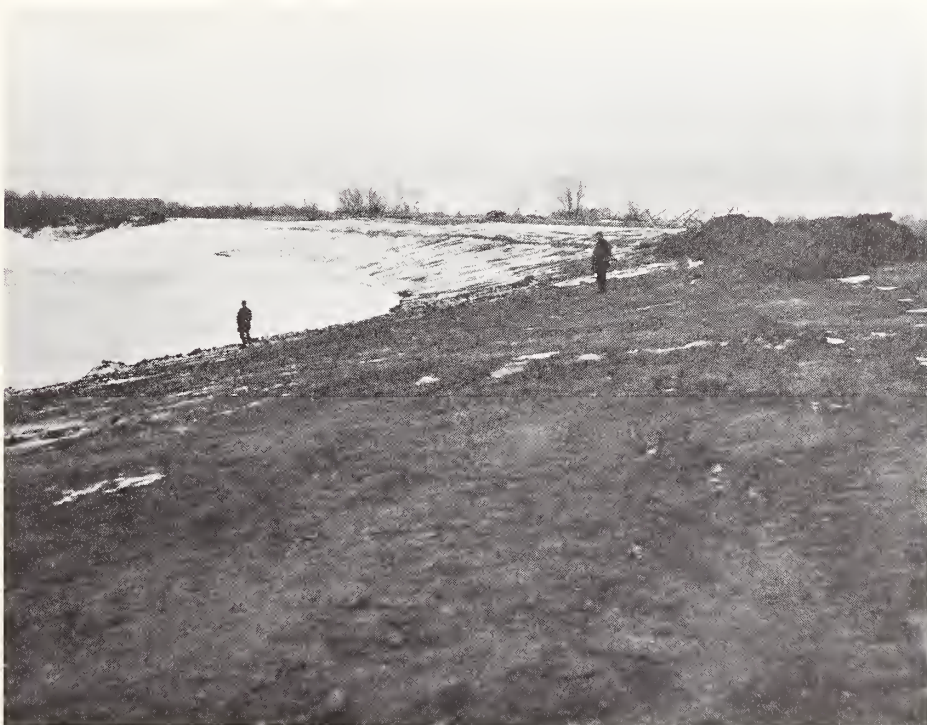
At Lateral PP-3, they are now sloping a rather sharp bend on the Yellowstone River and placing a gravel blanket. Trying to control this sharp a bend is almost an impossible problem. The bend now has a radius of curvature of approximately 1,200 feet, which is compared to a mean width on the Yellowstone River in this area of about 800 feet. A normal radius of curvature for a stable channel is a radius equal to 8 to 10 times the top channel width. This would indicate a radius along the Lower Yellowstone River of 6,400 to 8,000 feet. In some cases, this radius can go down to as low as 6 times the width, which would be about 4,800 feet in the Lower Yellowstone River. However, a radius of 6 times the width may require bank control measures. It is realized that this work on the Lower Yellowstone is experimental, and under these conditions the gravel blanket being placed at Lateral PP-3 will provide a test on the scouring action at a sharp bend. With the present slope of the gravel blanket on the 4:1 or 5:1 slope, there is a definite need for protecting the toe of this bank by placing either large rock or large-size jacks.

P14-600-372NA--Lower Yellowstone S&MC--December 16, 1970. Yellowstone River after bank sloping in Lateral PP-3 Charal farms area. Material for gravel blanketing and some jacks are in background.

The need for additional bank protection has been demonstrated as was anticipated. Therefore, four additional rock jetties were installed. The upper rock jetty containing 3,000 yards of rock and the second jetty containing 2,000 yards of rock were keyed into the bottom and banks as they were the key structures. Because of difficulty in working conditions and a lack of a good working base for a dragline, the lower two jetties, containing 1,500, and 1,000 cubic yards, respectively, were not keyed in. This was a calculated risk, but with the gravel blanketing, and 150 steel jacks to be installed and anchored, the river bank should be stabilized.

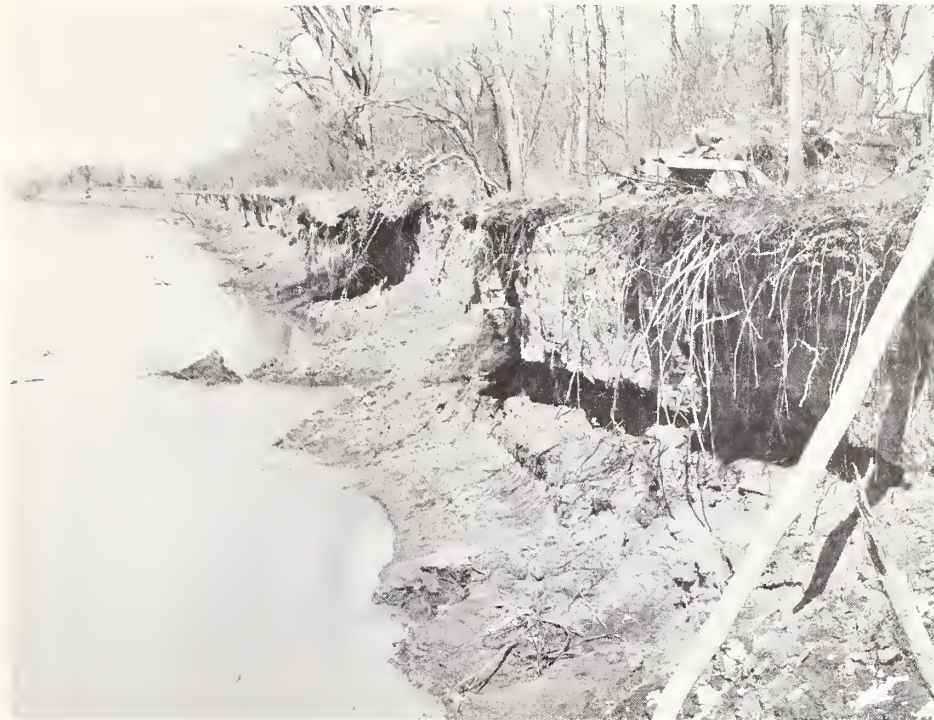
P14-600-364NA--Lower Yellowstone S&MC--1966. A typical vertical bank along river near State line. Sand strata in profile erodes easily.

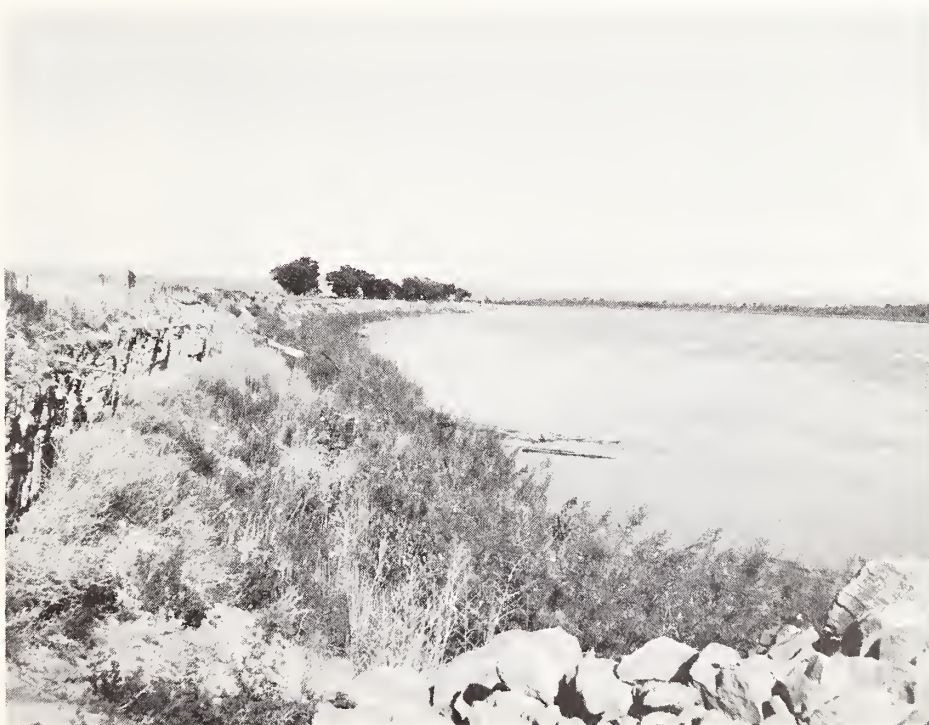
P14-600-335NA--Lower Yellowstone S&MC--June 1970. Yellowstone River bank near State line has been stabilized by rock jetties and steel jacks.

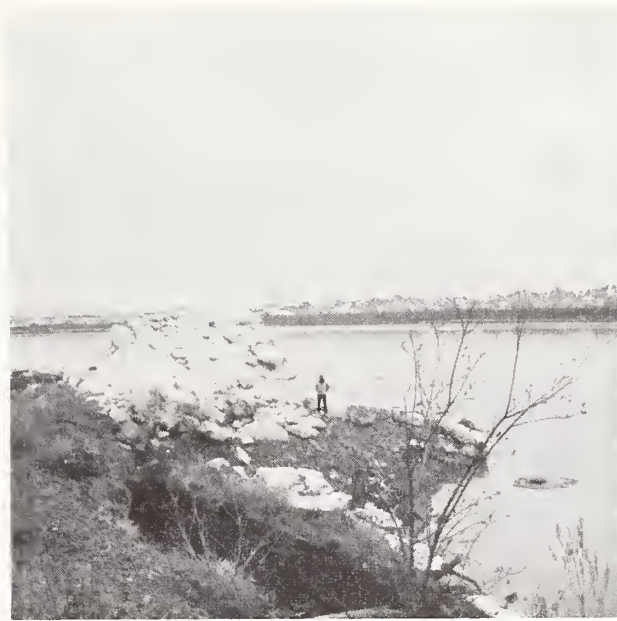
Lower Yellowstone--S&MC--March 1969. Ice piled at rock jetty during spring breakup.

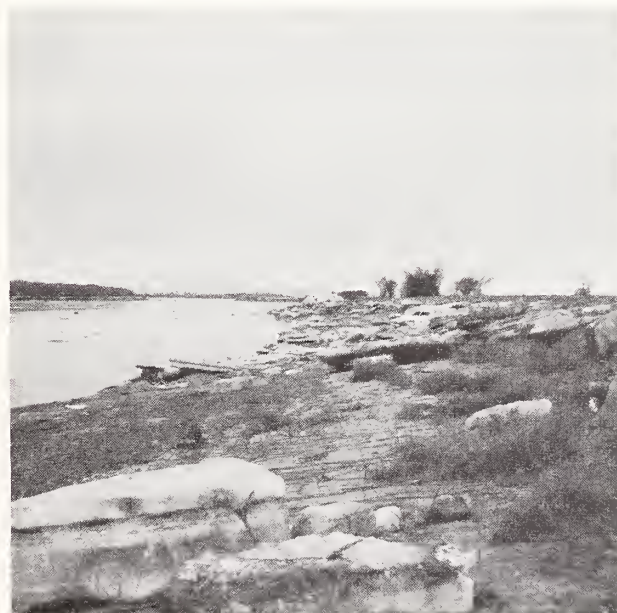
Lower Yellowstone--S&MC--March 1969. Ice deposited on sloping banks in State line area by high flows.

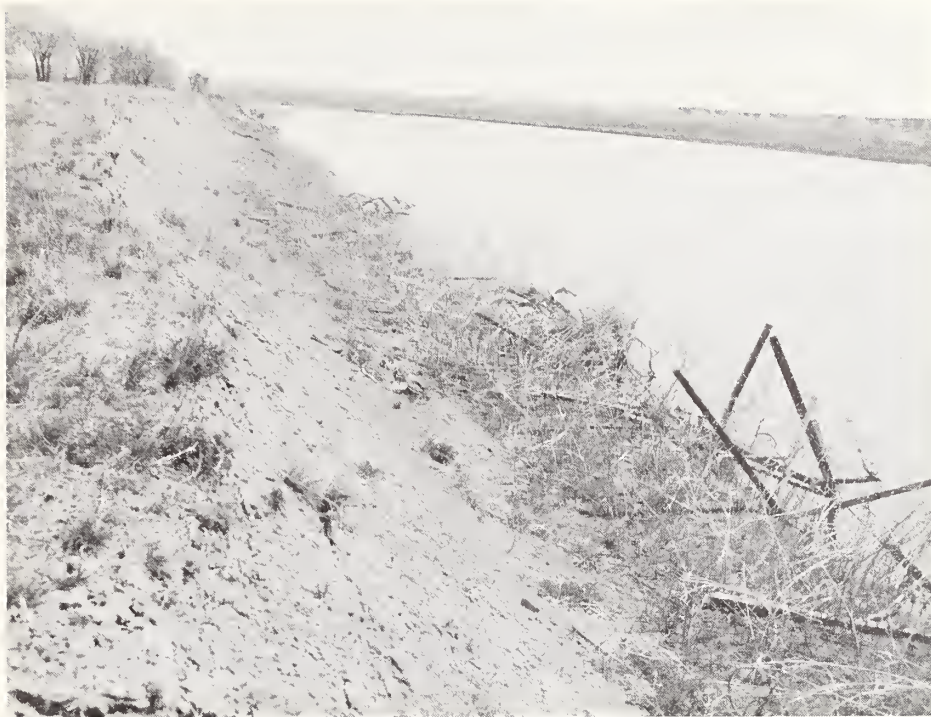
P14-600-341NA--Lower Yellowstone S&MC--May 7, 1971. Stabilized area between jetties No. 3 and 4 State line. Silt has been deposited as a result of steel jacks placed between rock jetties.

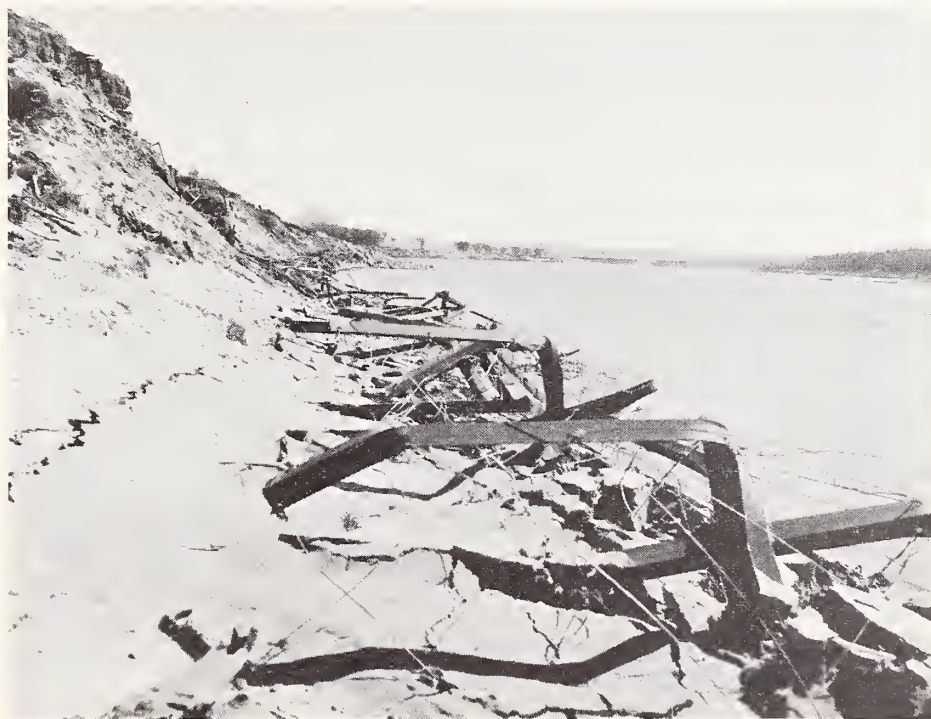
The jetties have done their work well but No. 1 and No. 2 have lost some rock off the points because of ice action. Forty-six jacks were lost because of ice action in 1968 and 100 jacks in 1972.

P14-600-367NA--Lower Yellowstone S&MC--April 21, 1969. Jacks crushed by ice but still effective - below Jetty No. 1 - State line area.

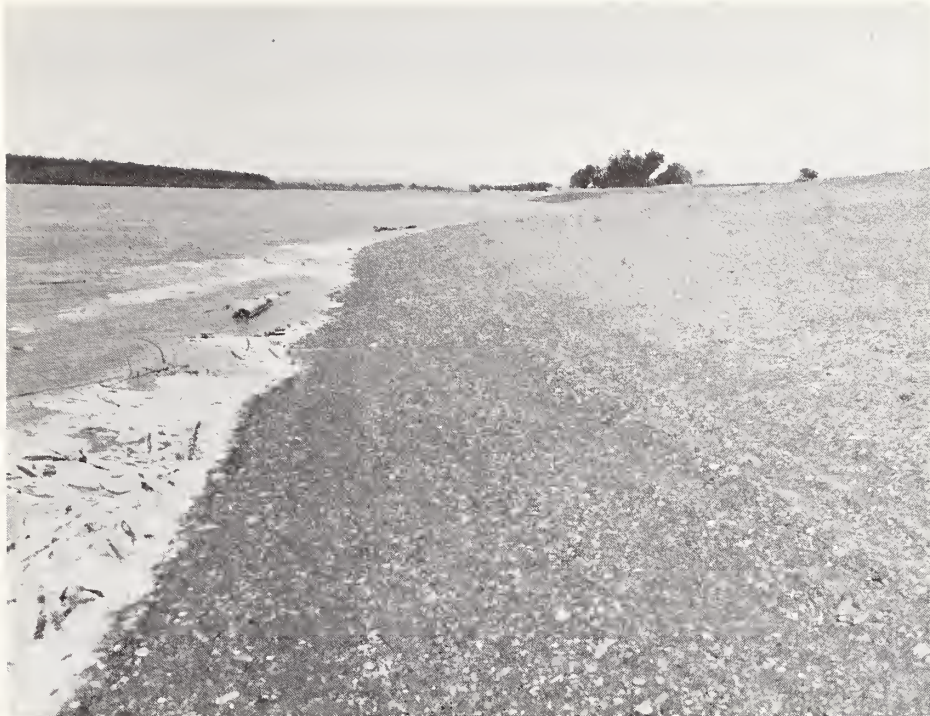
The bank sloping and gravel blanketing on this convex or inside bend is aesthetically attractive and has been relatively effective. However, it was necessary to repair one area where shifting currents or ice damage caused some erosion.

P14-600-366NA--Lower Yellowstone S&MC--June 9, 1970. Area below rock jetty stabilized by bank sloping and gravel blanketing near State line.

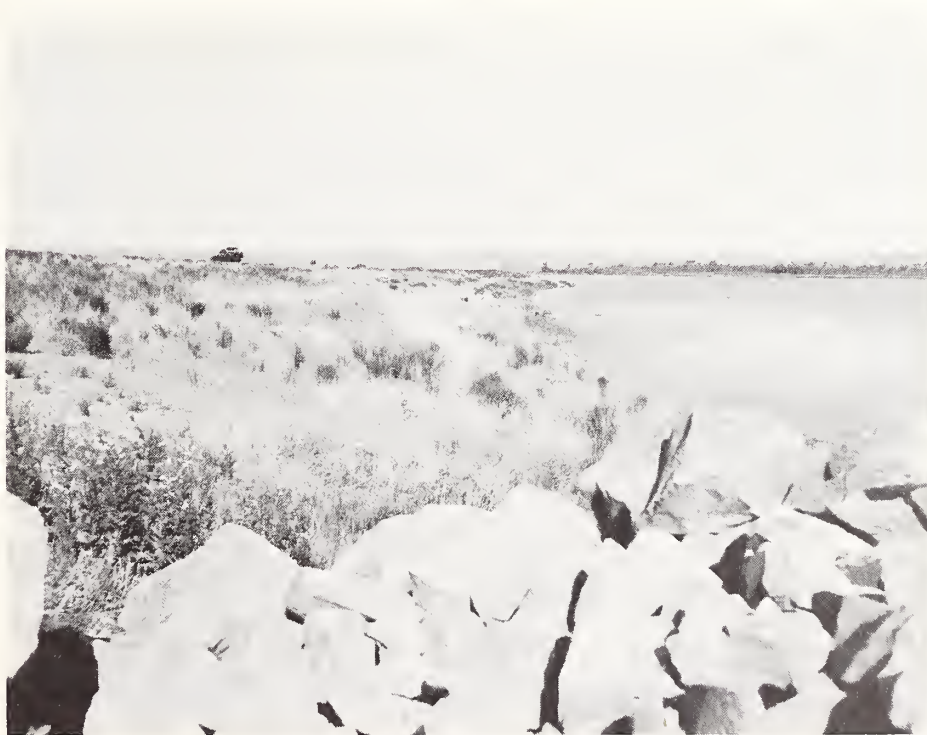
P14-600-292NA--Lower Yellowstone S&MC--June 12, 1968. Completed bank sloping and gravel blanketing near State line.

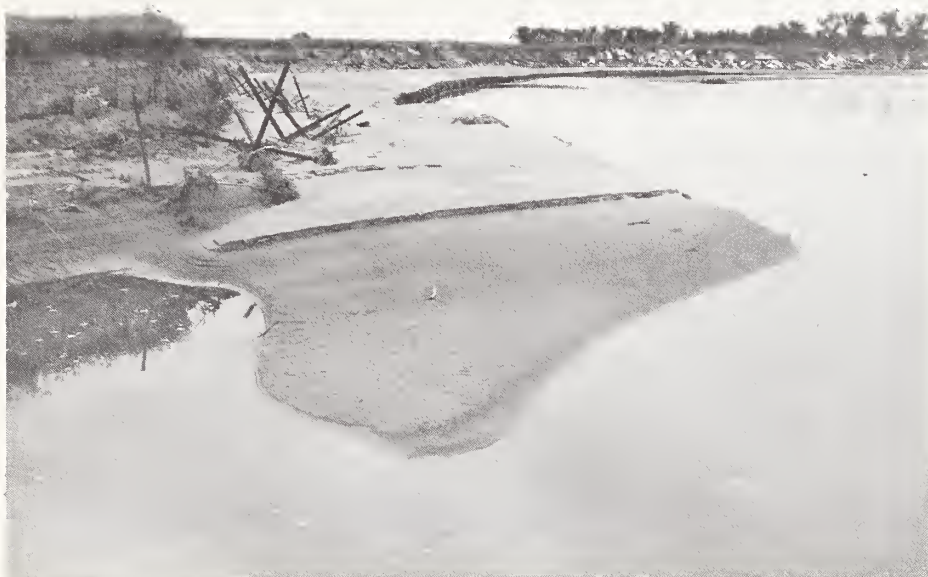
14-600-334NA--Lower Yellowstone S&MC--August 12, 1969.
Silt deposited below middle jetty in City
Lagoon Lateral D area.

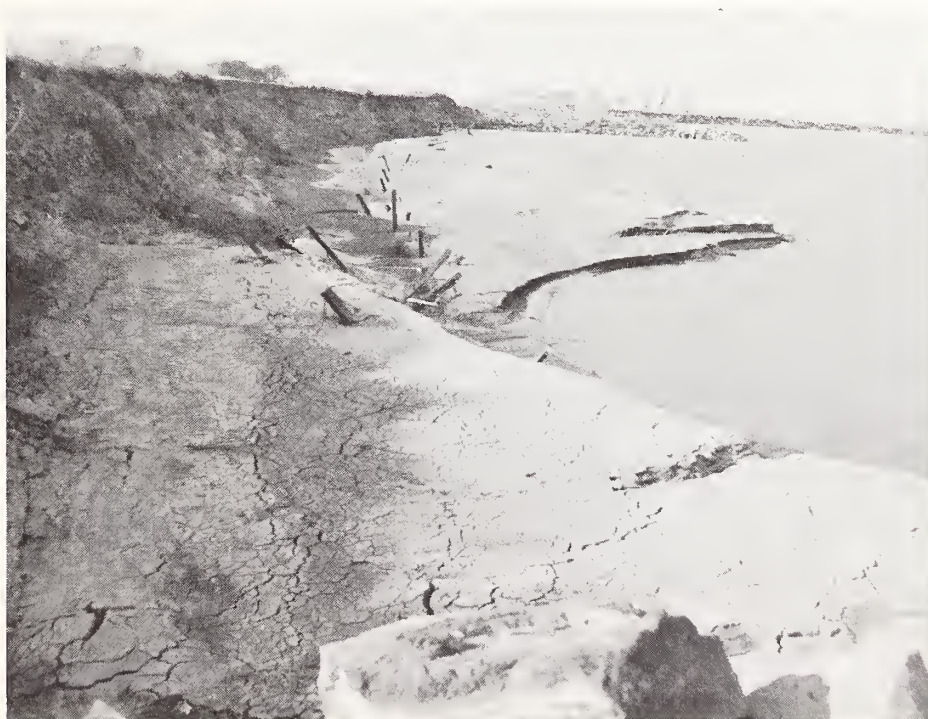
P14-600-363NA--Lower Yellowstone S&MC--May 6, 1971. Steel
jacks buried by silt below upper rock jetty--
City Lagoon Lateral D area.

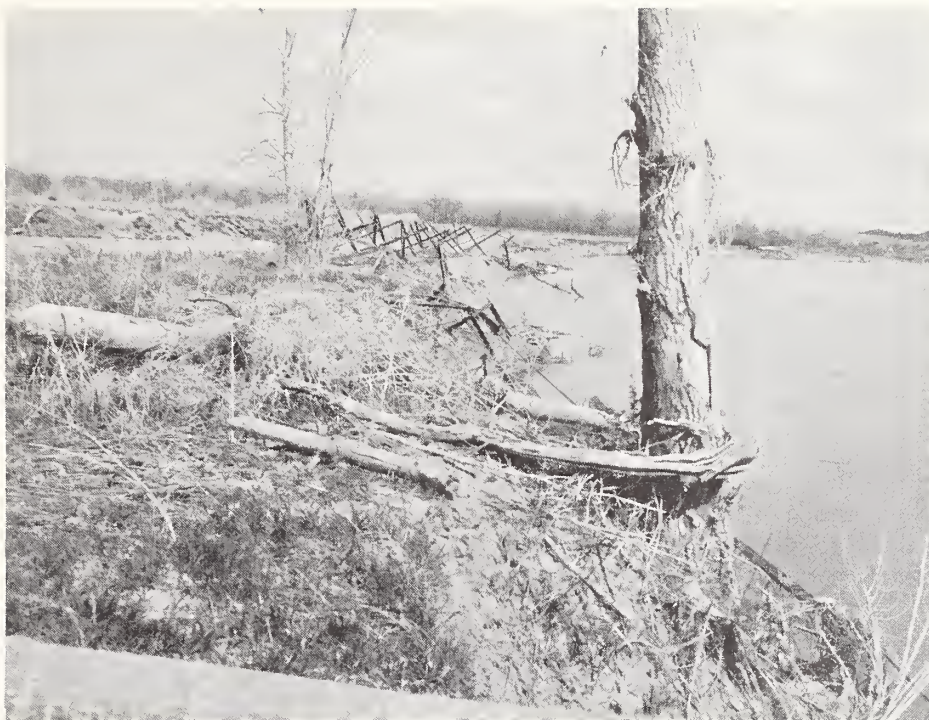
This stretch of the river is not as unstable nor as subject to bank erosion as the areas downstream. The river banks at normal water levels are gravel and stable, but are overlaid with erosive sands. It is only during ice flows and June floods that damage occurs. The steel jacks are effective in protecting the river during June floods but the ice flows during the spring breakup have twice out of 3 years pushed the jacks upon the banks. The jacks had to be replaced back on the water line. It is evident that a rock jetty or two will be required to protect the jacks from ice damage.

P14-600-370NA--Lower Yellowstone S&MC--May 6, 1971. Lateral KK - Caudills - During spring breakup the ice forced the jacks up onto the banks.

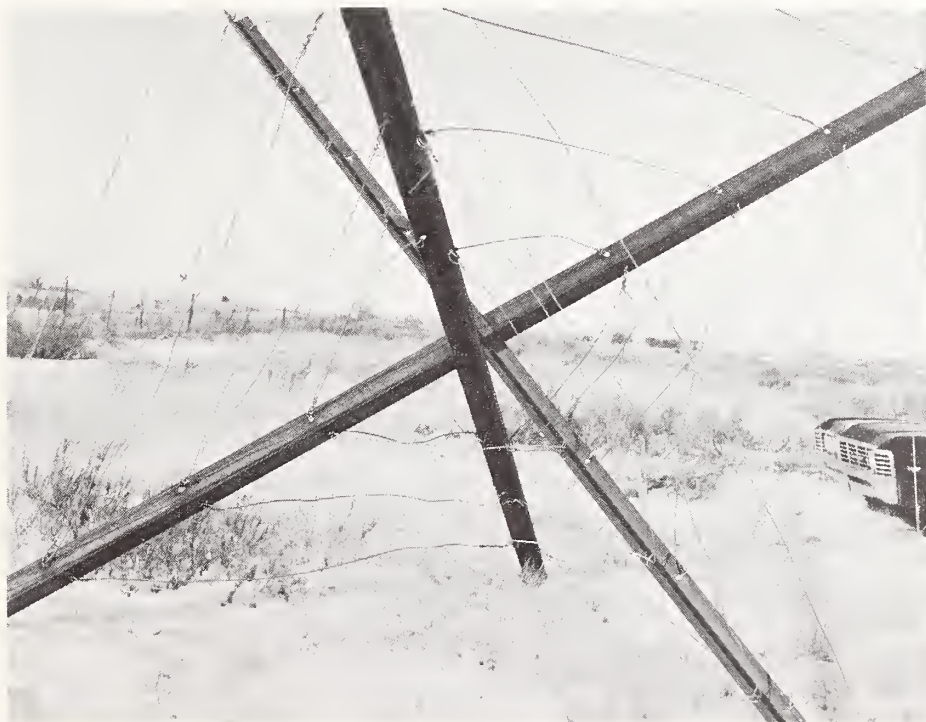
P14-600-287NA--Lower Yellowstone S&MC--January 30, 1969. Steel jacks - ready for installation. 4" x 4" x $\frac{1}{4}$ " angle iron - 16 foot long members welded together and wired with #6 wire.

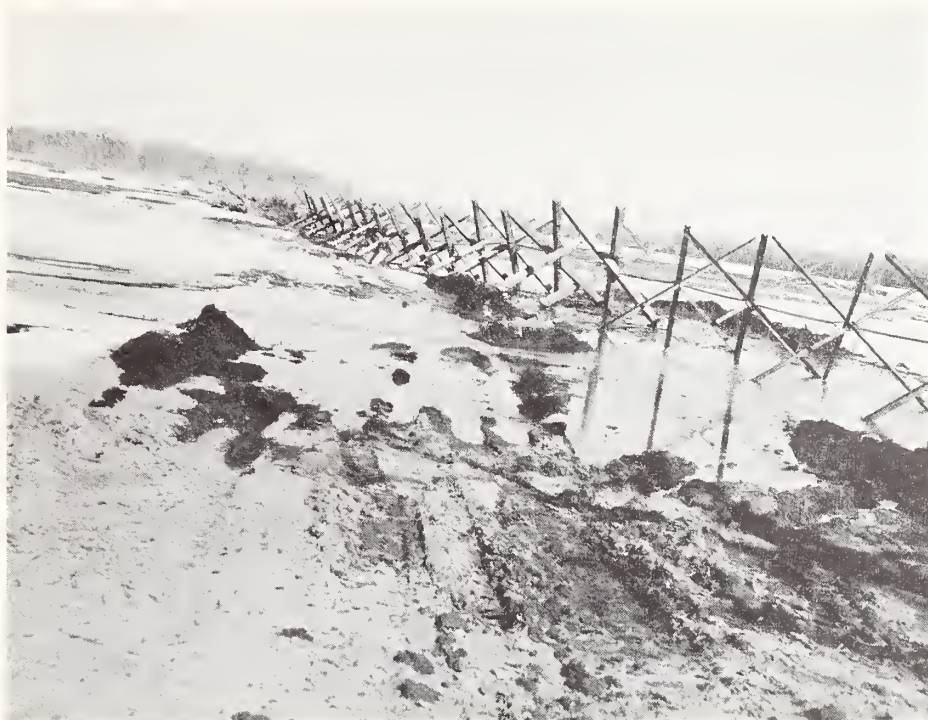
P14-600-375NA--Lower Yellowstone S&MC--March 19, 1970. Lateral NN.
Concrete and steel jacks in place in a side channel of
river. The purpose of this type of installation is to
reduce bottom degradation of such overflow channels.

It is planned that a rock dike about 600 feet long will be installed across this channel in 1973 at the elevation of the normal flood depth. This should catch ice and silt and help stabilize the channel.

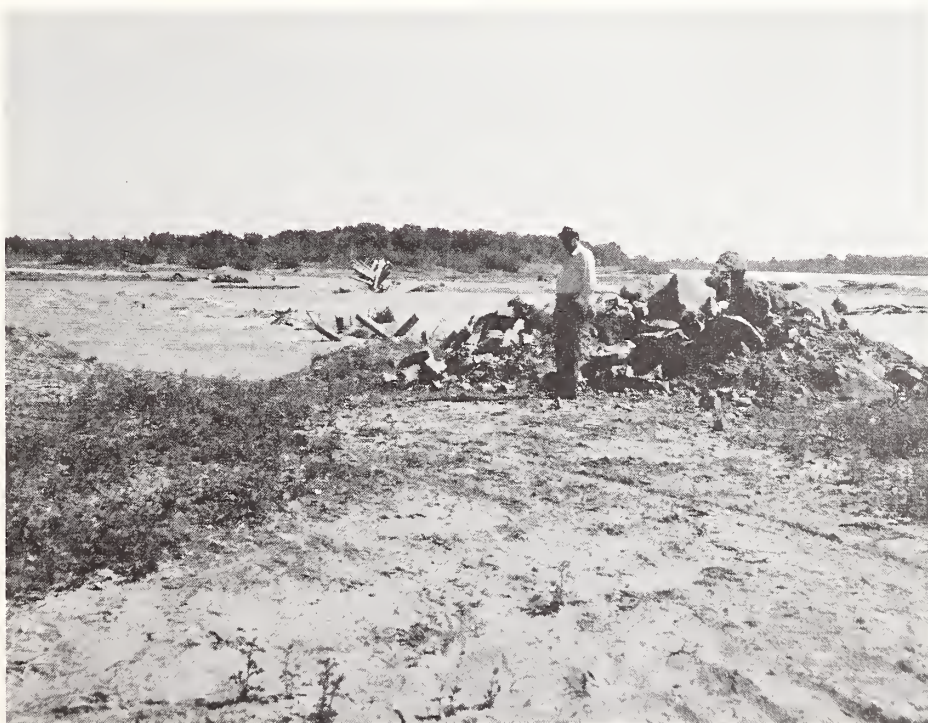
P14-600-376NA--Lower Yellowstone S&MC--June 9, 1970. Lateral NN.
Concrete jacks during high flows. Jacks were effective
this year.

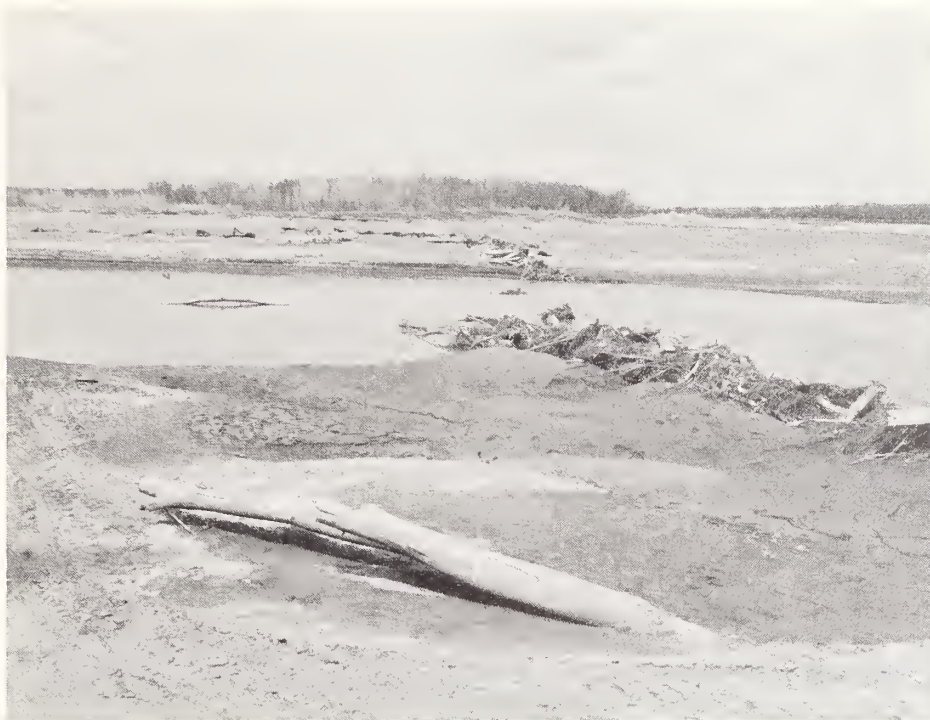
In 1969, 20 concrete jacks and 70 steel jacks were placed in a row across this side channel. The high ice flows broke the arms of the concrete jacks and flattened the steel jacks. Project equipment available for installing the jacks is not large enough to handle jacks of strength and size needed to withstand the ice flows in some years. In 1970, 35 concrete jacks and some steel jacks were installed in the same location. They withstood the ice and flood flows during that year. A large deposit of silt resulted from the installation. In the spring of 1971, however, ice flows again broke the concrete jacks. Although the steel jacks were crushed by the ice, they still retained some of their shape and were partially effective.

P14-600-373NA--Lower Yellowstone S&MC--May 6, 1971. Lateral NN - concrete jacks crushed by ice in spring.

Steel jacks might be used in this situation if two rows were installed and anchored securely by cable to deadmen.

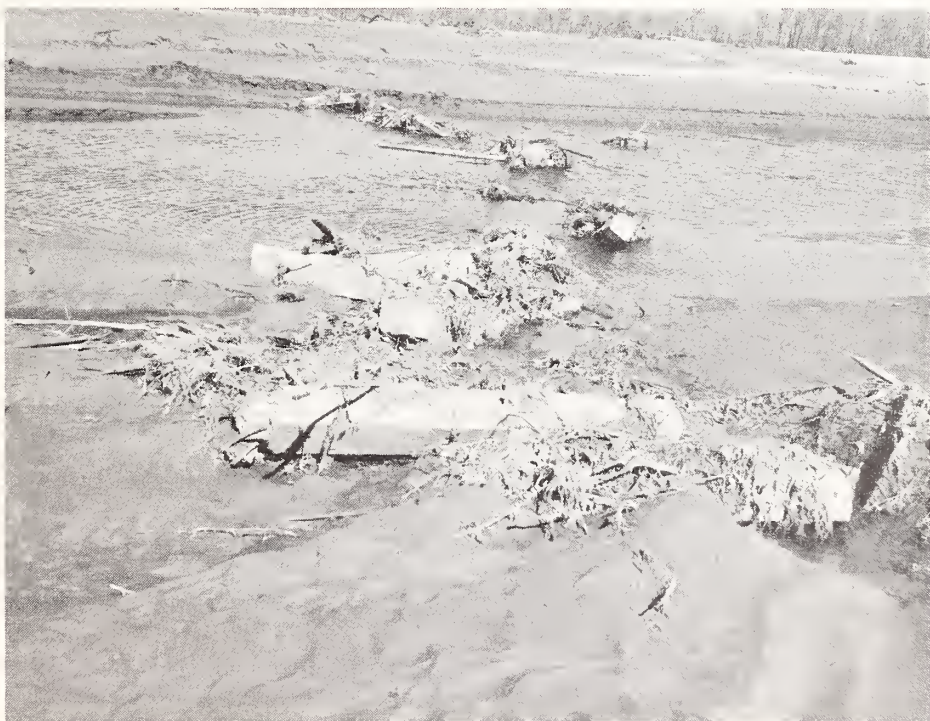
- (c) Concrete jacks are more expensive than the steel jacks, are heavier and harder to place. They are effective during flood flows but the action of ice breaks off the arms and makes this type of jack ineffective. Steel jacks are better and cheaper under these conditions.

P14-600-374NA--Lower Yellowstone S&MC--April 21, 1969. Closeup of concrete jacks crushed by ice. This type of jacks in sizes which can be handled by Project forces has proven ineffective.
